MEETING AGENDA
The City of Beaufort
HISTORIC DISTRICT REVIEW BOARD
Wednesday, May 14, 2025, 2:00 P.M.
City Hall, Council Chambers, 2nd Floor – 1911 Boundary Street, Beaufort, SC

III. Applications

B. 1107 Prince Street, PIN R120 004 000 0503 0000, alterations, additions
Applicant: Benjie Morillo, Architect, Frederick + Frederick Architects

Property to be inspected: 1107 Prince Street Beaufort, SC

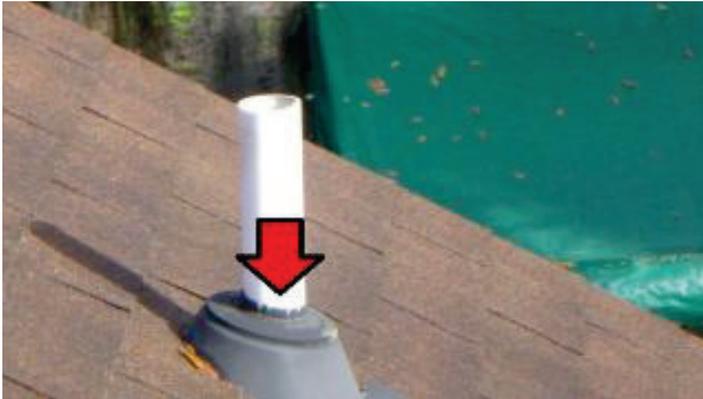
Rubber seal around the plumbing stacks on the roof shows deterioration and/or is cracked. This could allow water to penetrate or leak into the attic area. Some cracks can be sealed with roof mastic or tar, while others are too large so the boot vent will have to be replaced.

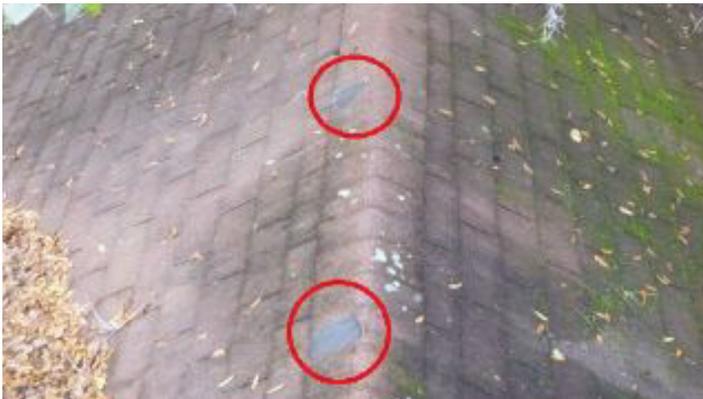
Damaged or missing roof shingles found on the ridge on the roof.

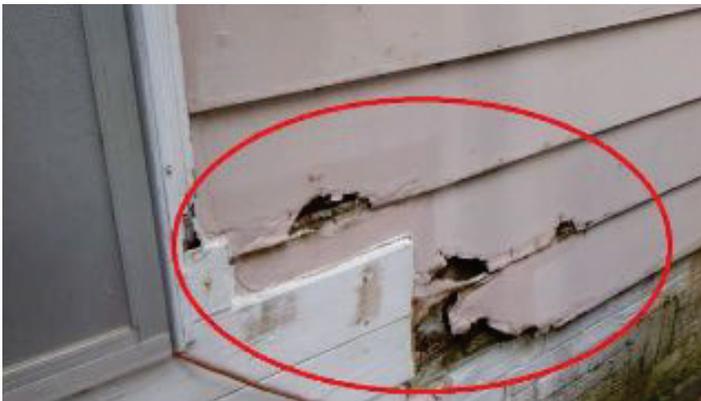
Extensive dry rot/water damage found on the wood siding on the back of the home.

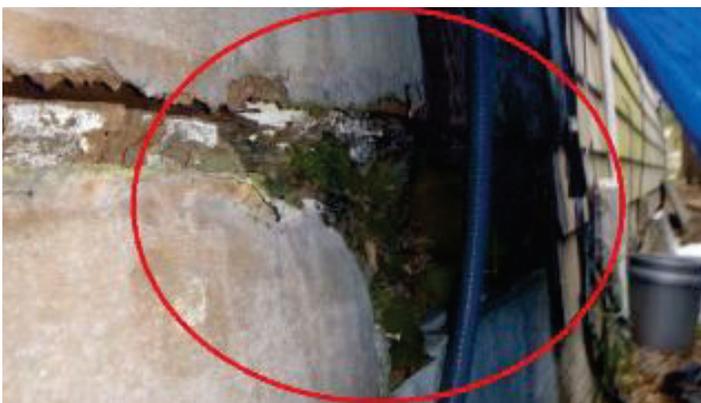
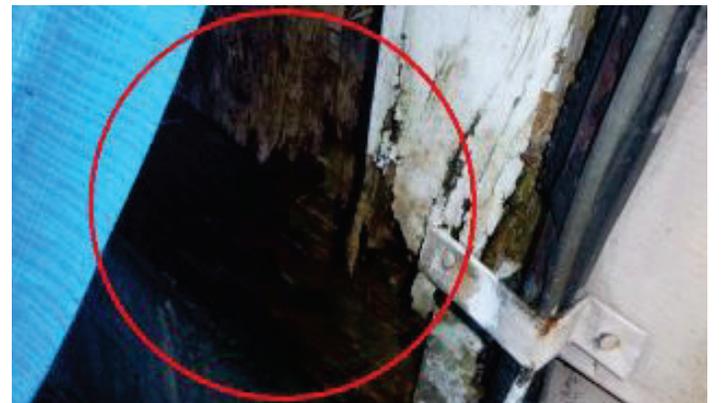
Dry rot/water damage found on the wood siding on the left side of the home.

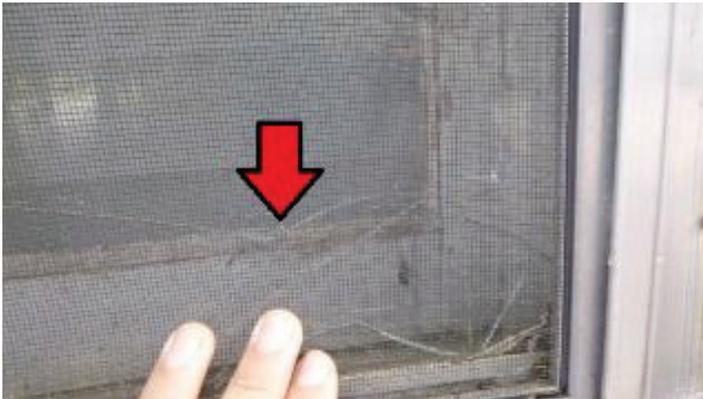
Cracked or hole found in the window pane on the front bedroom of the home.

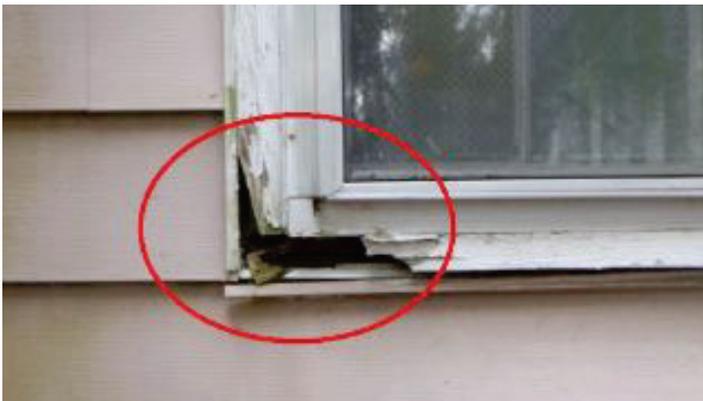
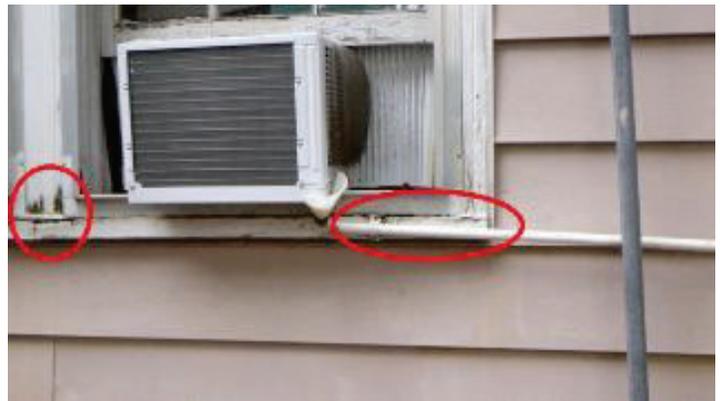
Dry rot/water damage found on the exterior sill and/or trim sections of the window located on the kitchen.

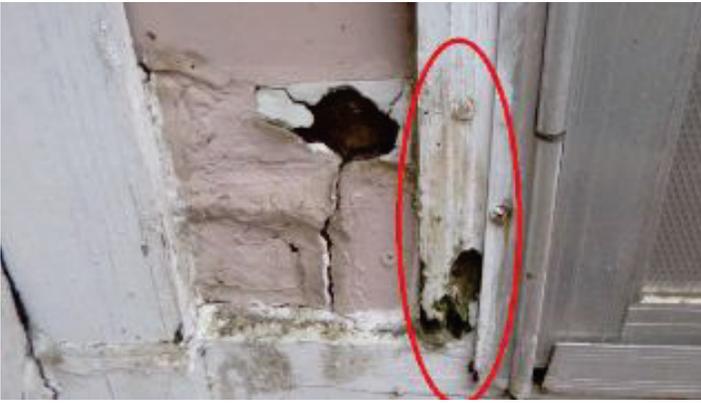
Dry rot/water damage found on the bottom of the door casing and/or trim on the back of the home.

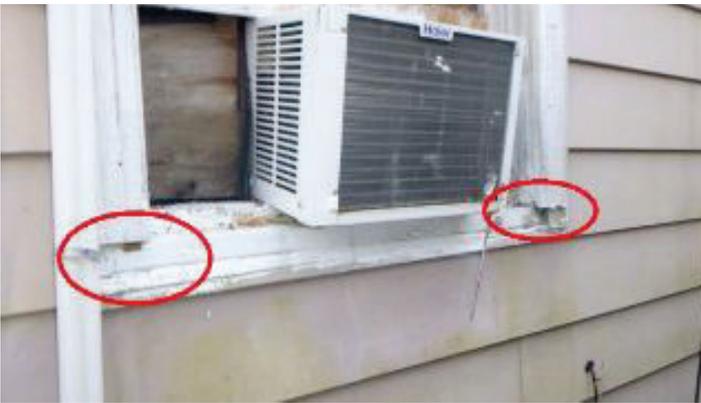
Dry rot/water damage found on the exterior sill and/or trim sections of the window located on the left side of the home.

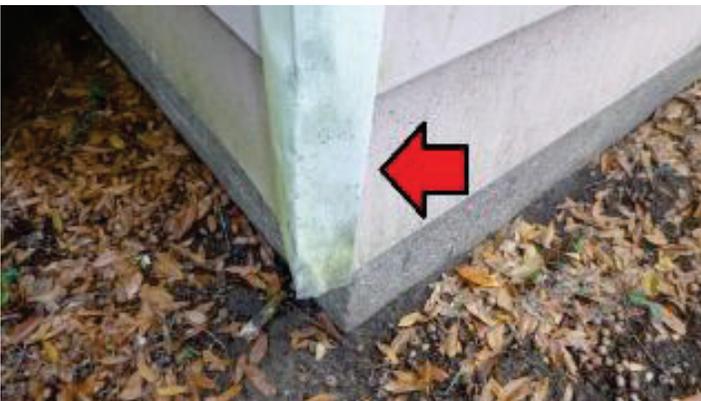
Dented/ damaged aluminum corner trim noted on several corners.

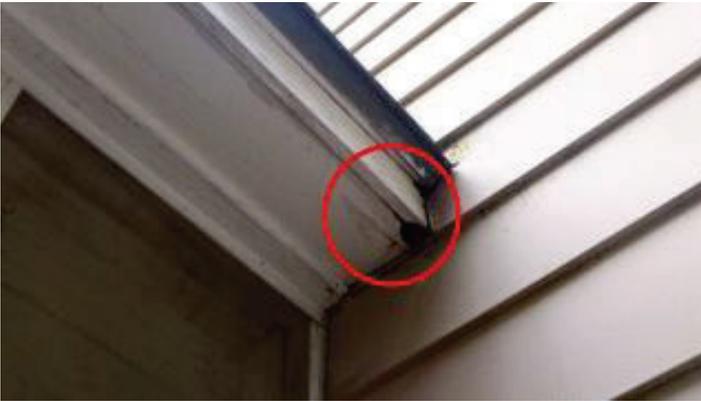
Dry rot/water damage found on the soffit and or fascia boards (eaves) on the right side of the home.

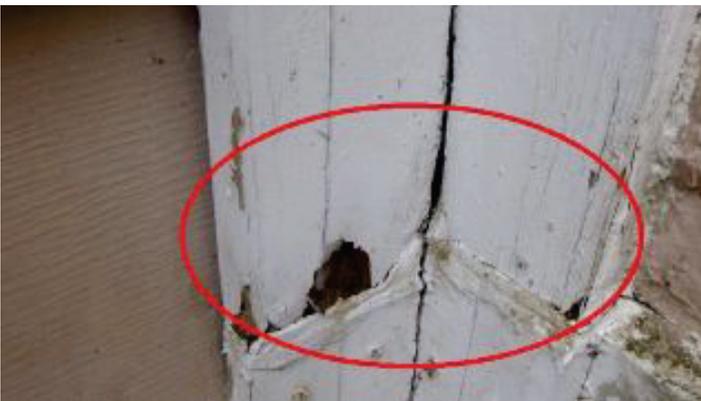
Dry rot/water damage found on the corner trim on the back corner of the home.

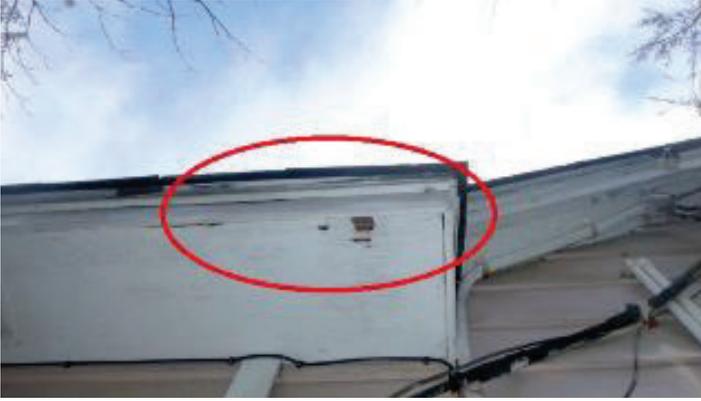
Dry rot/water damage found on the soffit (eaves) on the left side of the home.

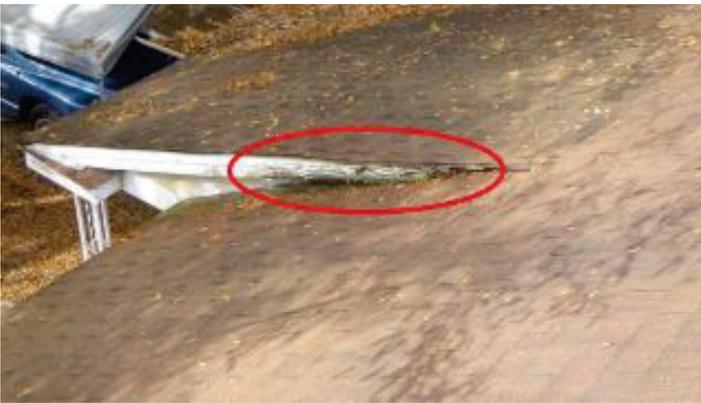
Dry rot/water damage found on the fascia board (eave's) located on the right side of the home above the roof line.

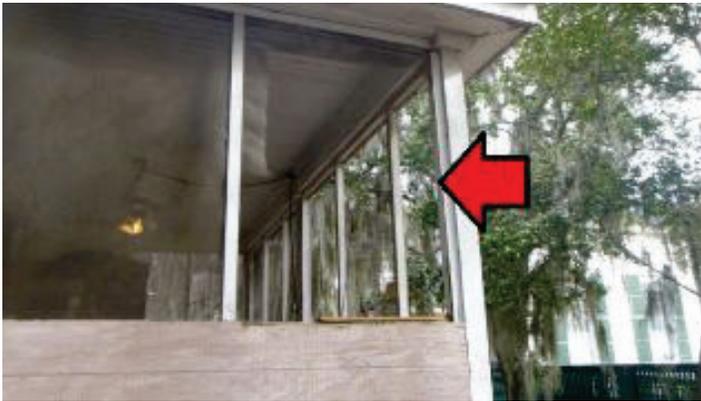
Screen found torn on the screen porch.

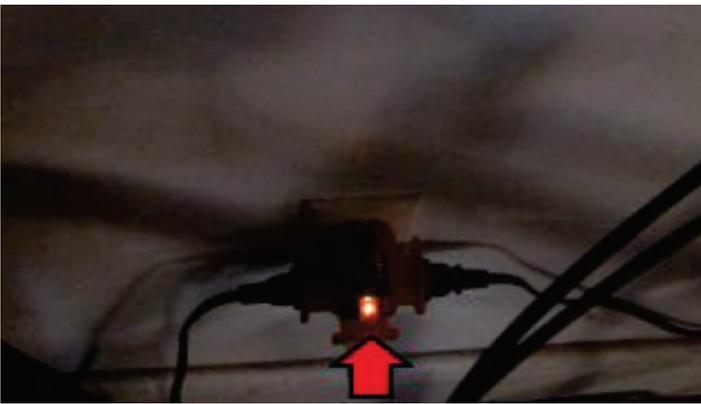
Open ground receptacles/outlets found throughout the home. Many are 3-prong outlets that have been upgraded from 2-prong outlets. This is common in older homes or homes with 2 wire ungrounded electrical wires. Recommend consulting a licensed electrician on proper installation or upgrade.

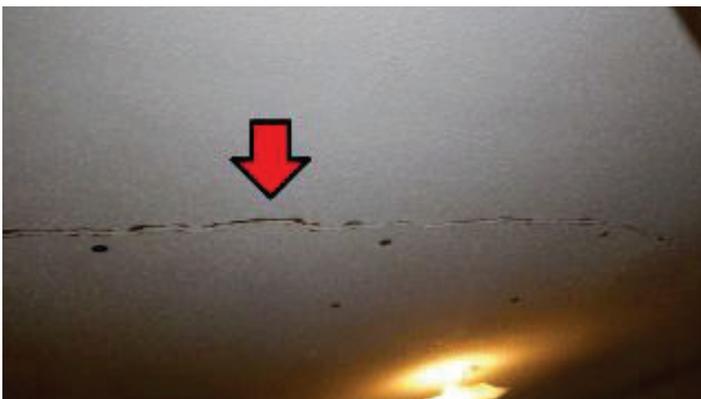
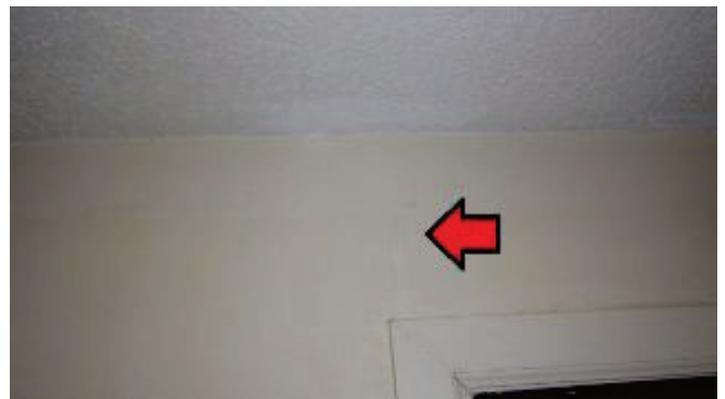
Cosmetic cracks found in the ceiling and walls in several areas.

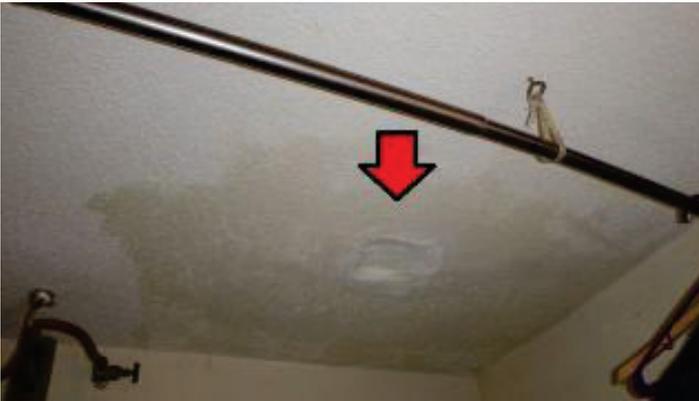
Sheetrock has unfinished patch or repair and/or visible repairs located in several areas.

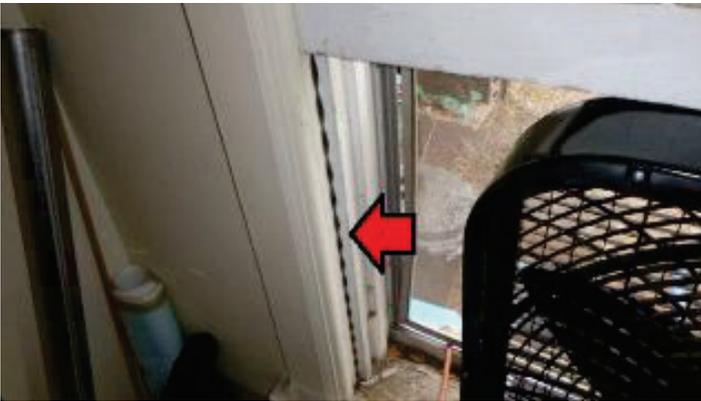
Window track appeared to be broken and/or the springs are worn. Window would not stay in the up position when tested in the follow areas: back left bedroom .

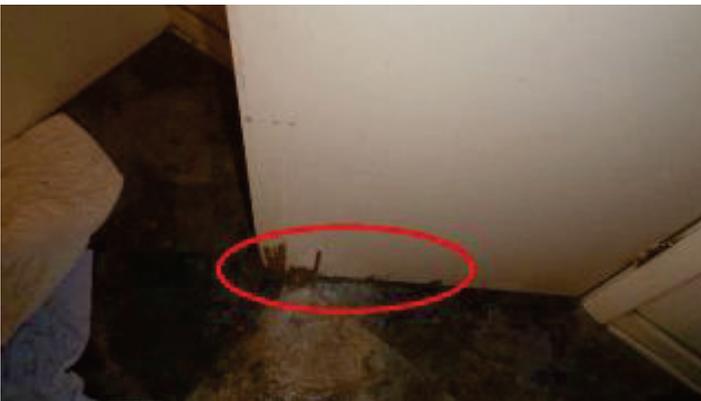
Doors appear to be delaminating in the back bedroom.

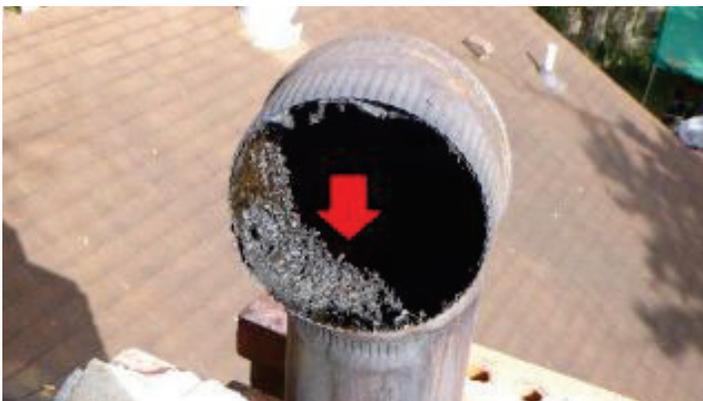
Soot and/or cresol build up found in the fireplace. Recommend cleaning by a certified chimney sweep.

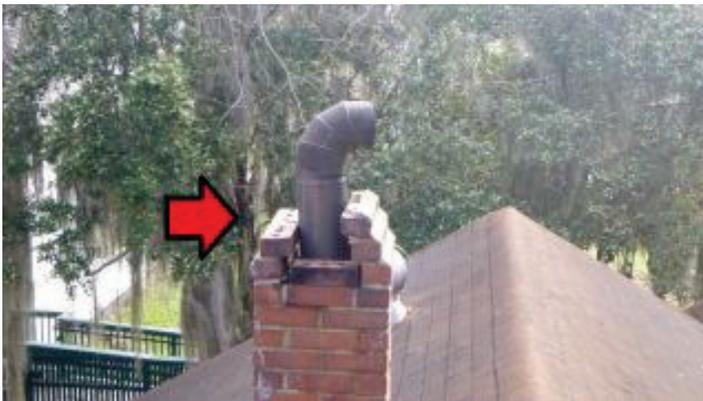
Chimney does not appear to meet today's construction standards. Recommend further evaluation and repair by licensed builder.

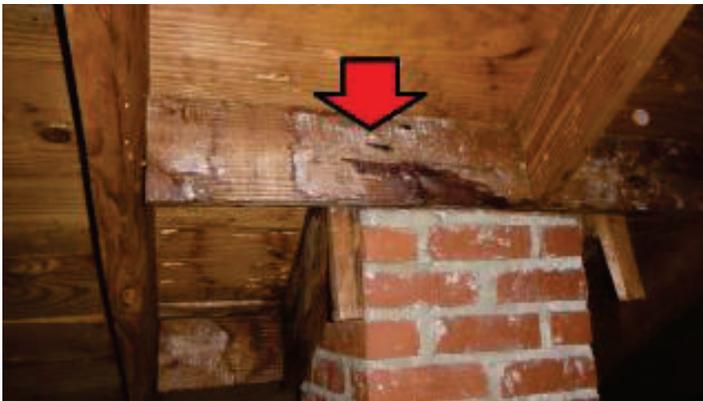
Water stain found on the interior of the chimney or side of the chimney (viewed from the attic). Moisture meter indicated an inactive leak (dry) at the time of inspection.

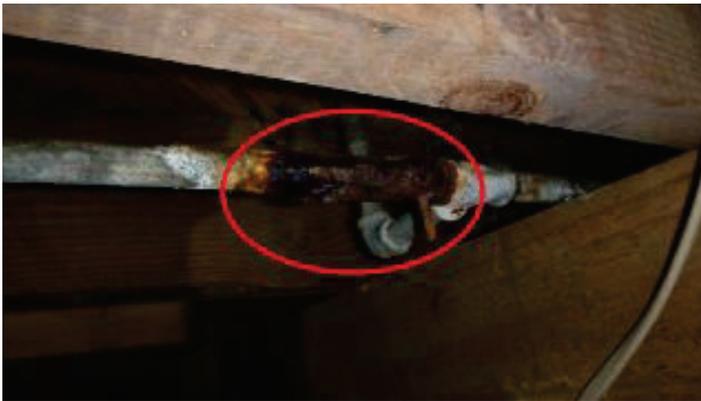
Active leak noted on the supply line under the front bathroom.

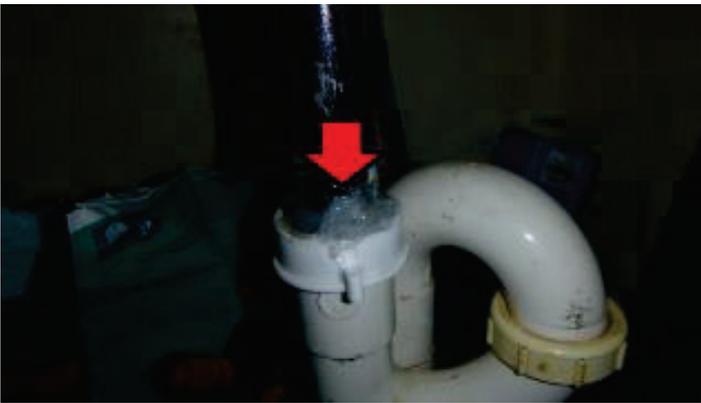
Improper repair noted under the back bathroom sink. Caulk is not an acceptable repair for plumbing.

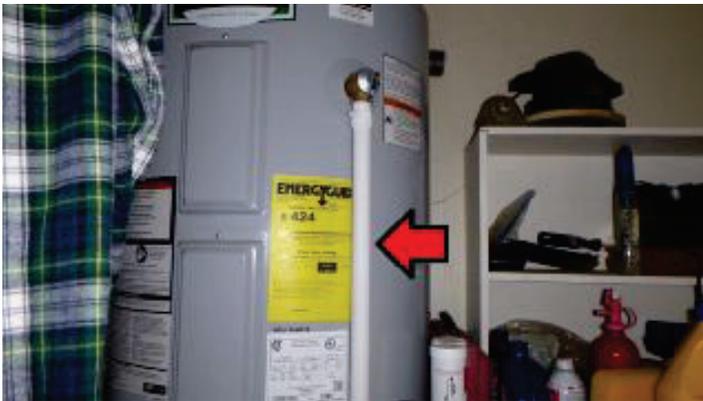
PVC pipe installed on the water heater pressure relief valve (P&T valve). PVC pipe is not rated for hot water. If the P&T valve opens the pvc could melt or come apart and cause water damage. Recommend replacing line.

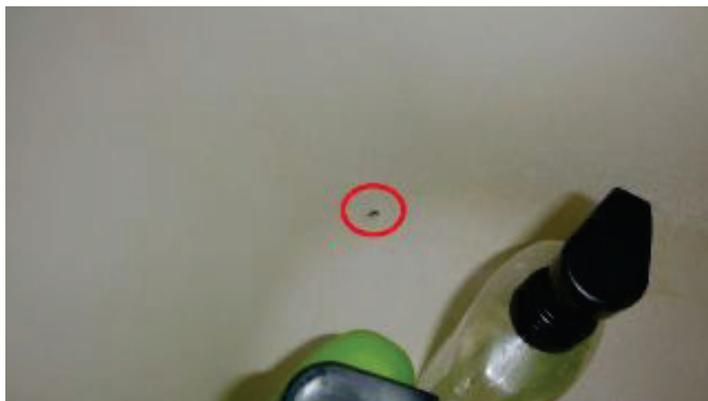
Cracks found in the bottom of the fiberglass tub/shower. It is not always possible to determine if the cracks are leaking without putting weight on the damaged area. See crawlspace section for more findings.

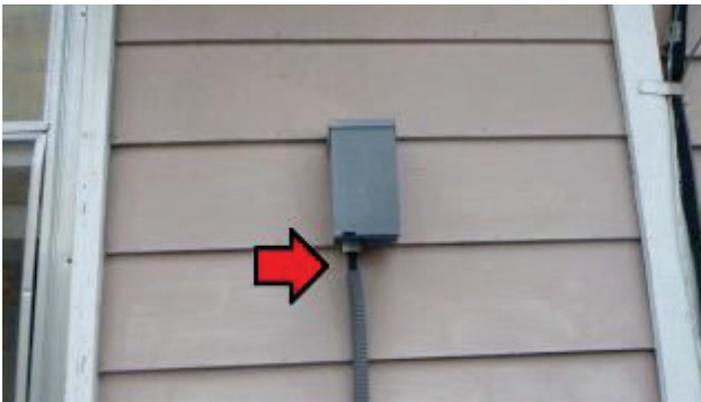
Loose conduit found on the electrical disconnect box for the exterior HVAC unit. Exposed electrical wires noted.

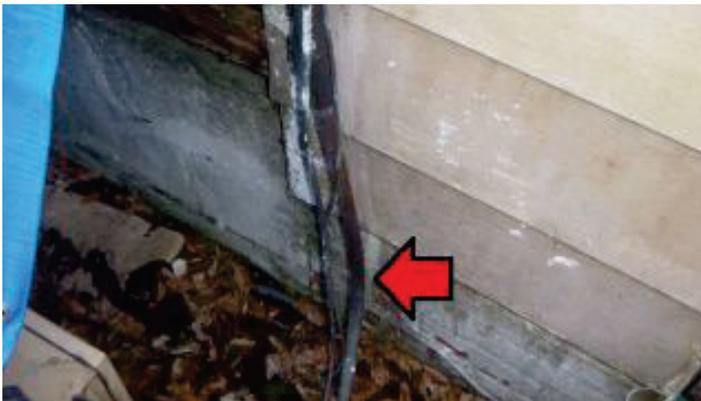
The insulation on the suction line to the condensor (exterior HVAC unit) is deteriorated/not installed. The suction line is the line that connects the condensor to the airhandler (interior HVAC unit),

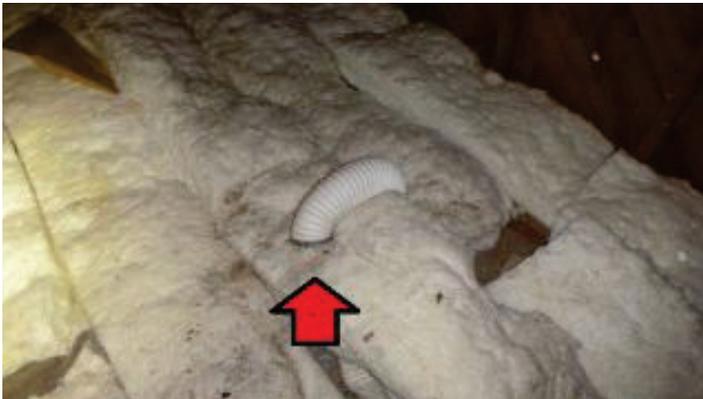
Bathroom exhaust was not duct to exterior wall area in the attic. This could allow moisture to build up in the attic.

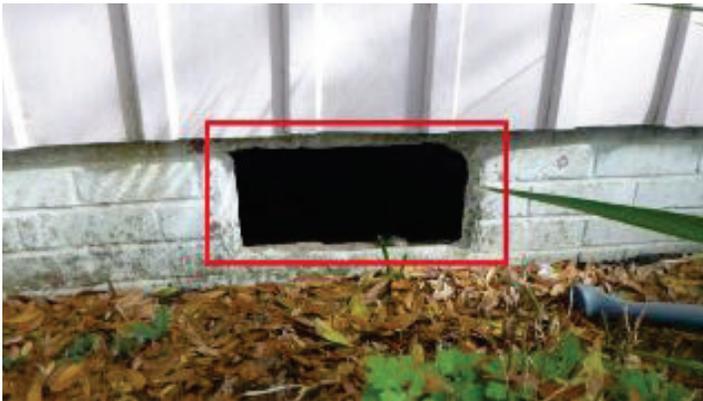
Missing or damaged foundation vents noted in several locations on the home. This could allow pest (rodents and insects) access to the crawlspace.

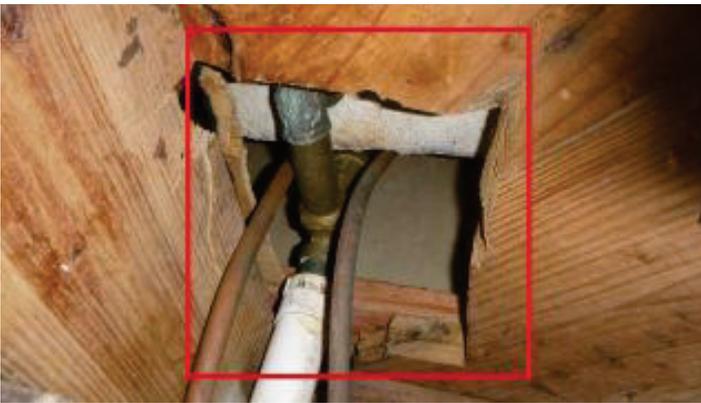
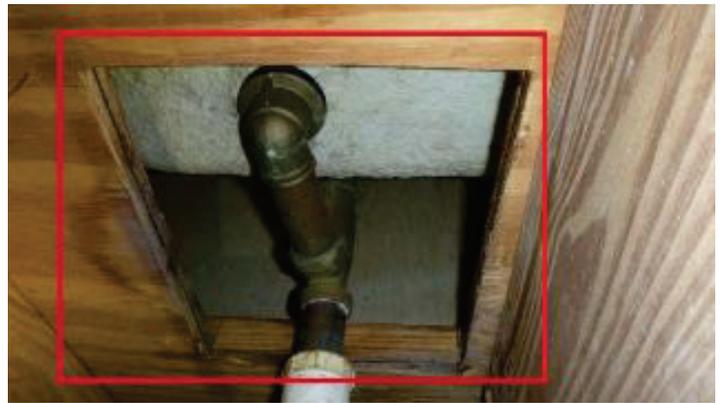
Excessive opening in the sub floor under the bathrooms. This could allow pest or rodents access.

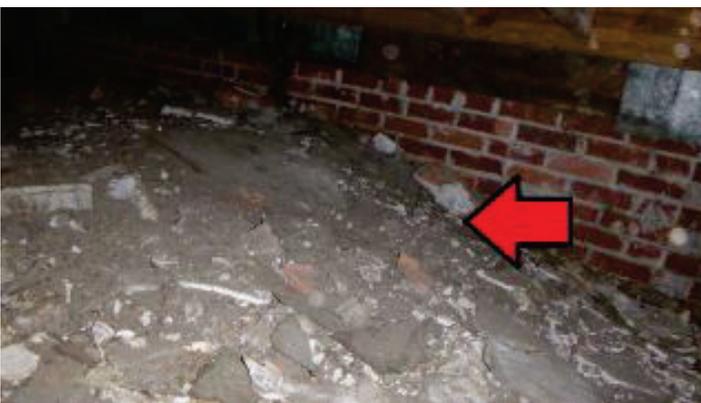
Debris or old construction material noted in the crawlspace. Recommend removing to prevent attracting insect or pest.

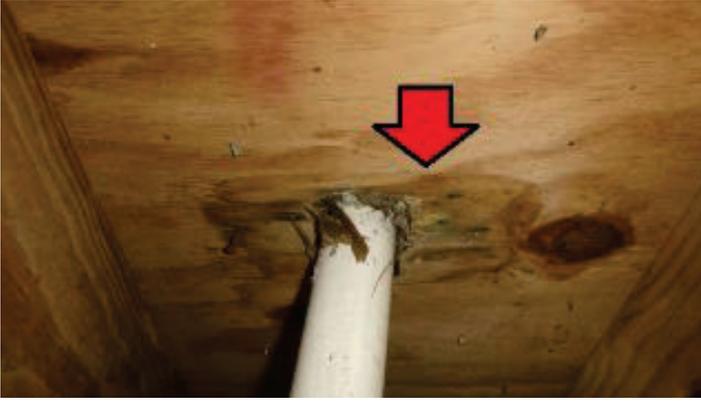
Water stains noted under the laundry room on the sub-floor or framing. Moisture readings show an in-active leak (dry) at the time of inspection.

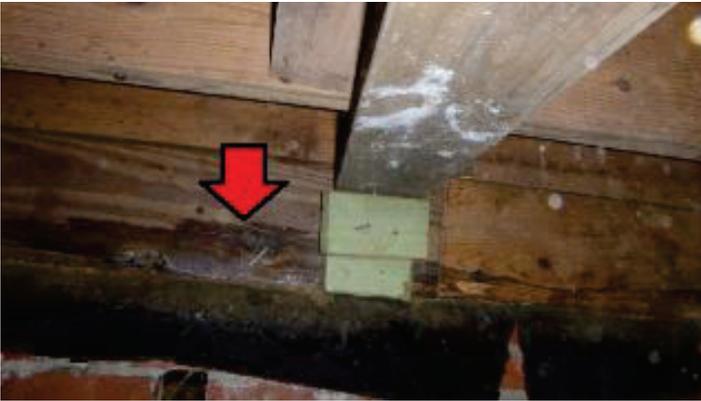
Water stains noted under the right side of the home on the sub-floor or framing. Moisture readings show an in-active leak (dry) at the time of inspection.

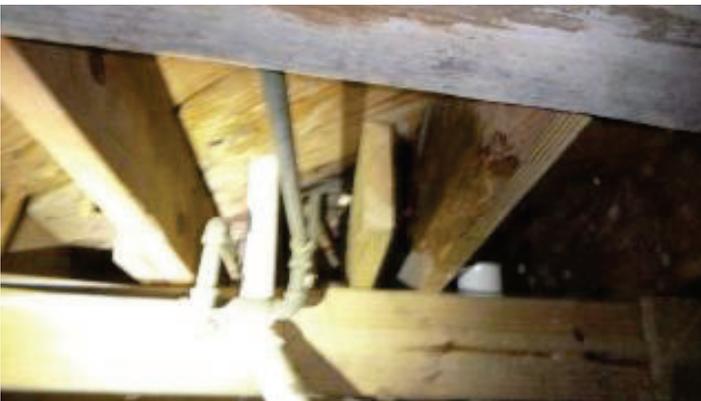
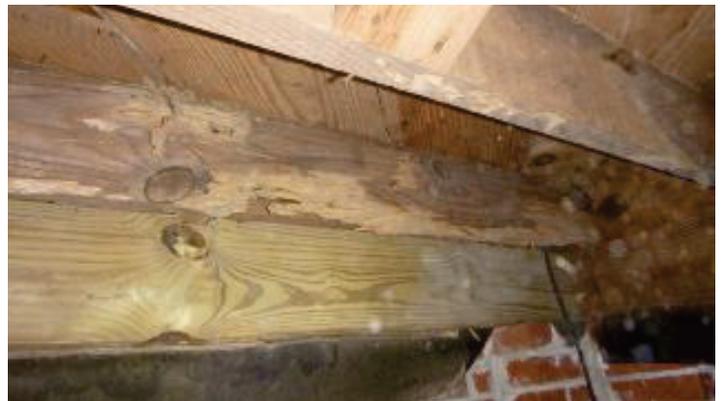
Multiple visible repairs noted in the crawlspace. This is common in older homes. Inspector does not grade the quality of the repair. Recommend consulting present owner on these repairs.
