MEETING AGENDA
The City of Beaufort
HISTORIC DISTRICT REVIEW BOARD
Wednesday, May 14, 2025, 2:00 P.M.
City Hall, Council Chambers, 2nd Floor – 1911 Boundary Street, Beaufort, SC

III. Applications

B. 1107 Prince Street, PIN R120 004 000 0503 0000, alterations, additions
Applicant: Benjie Morillo, Architect, Frederick + Frederick Architects

Property to be inspected: 1107 Prince Street Beaufort, SC

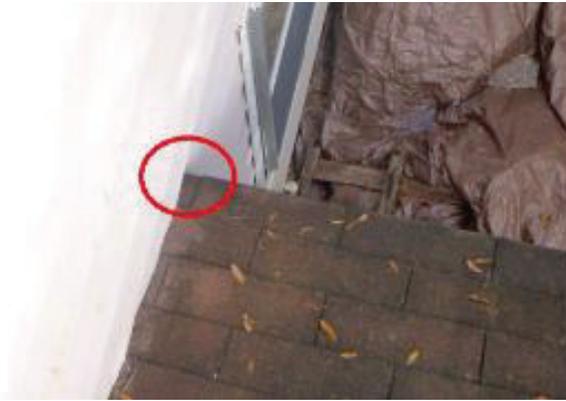
Minor Repair

Rubber seal around the plumbing stacks on the roof shows deterioration and/or is cracked. This could allow water to penetrate or leak into the attic area. Some cracks can be sealed with roof mastic or tar, while others are too large so the boot vent will have to be replaced.

**Minor Repair**

Damaged or missing roof shingles found on the ridge on the roof.

Improper flashing noted on the roof. Kick outs not installed at the end of the step flashing. This could allow water behind the siding.

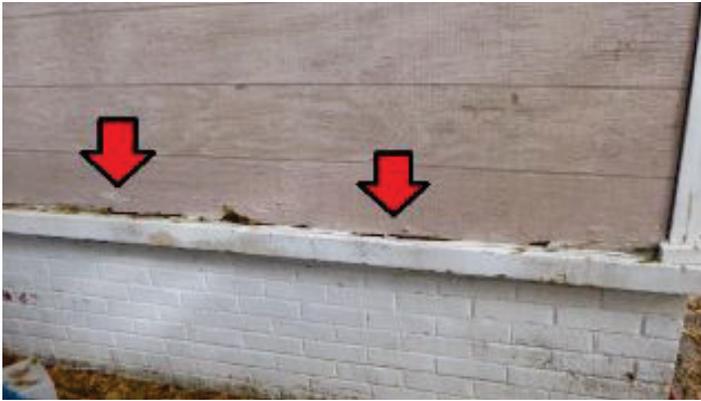
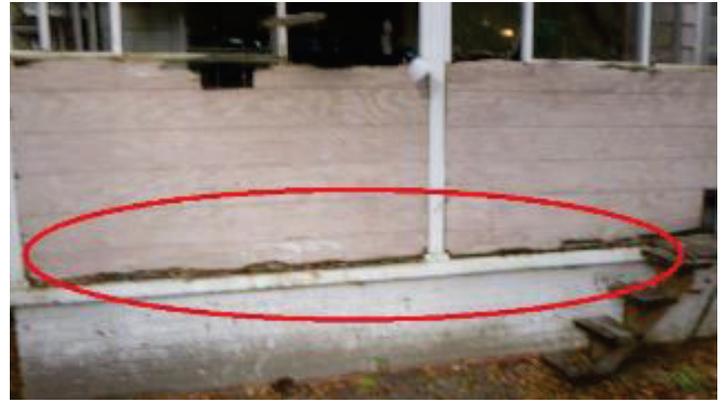
Minor Repair

Dry rot/water damage found on the wood siding on the screen porch of the home.

Extensive dry rot/water damage found on the wood siding on the back of the home.

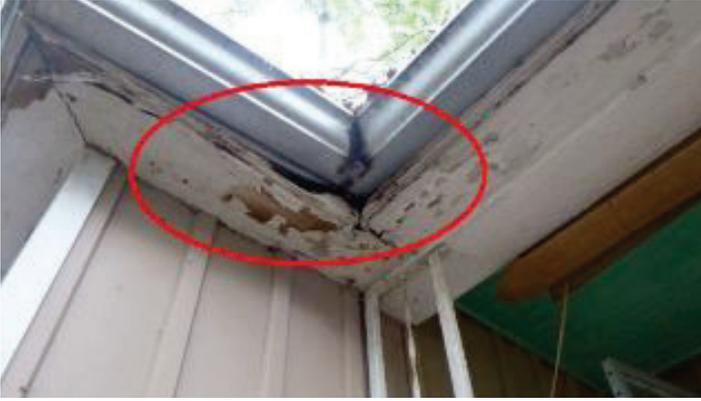
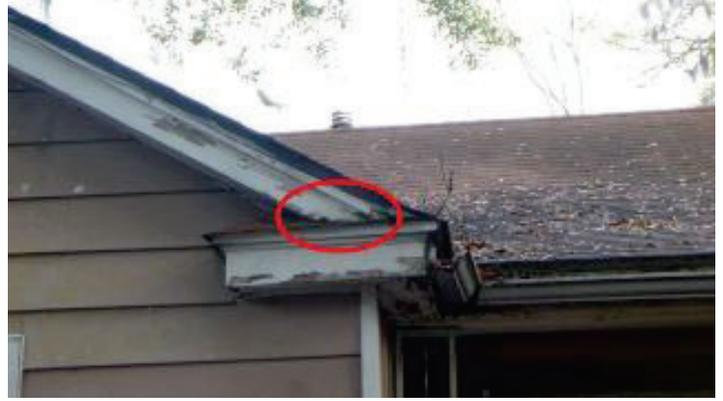
Minor Repair

Dry rot/water damage found on the soffit and or fascia boards (eaves) on the front porch of the home.

Dry rot/water damage found on the soffit and or fascia boards (eaves) on the right side of the home.

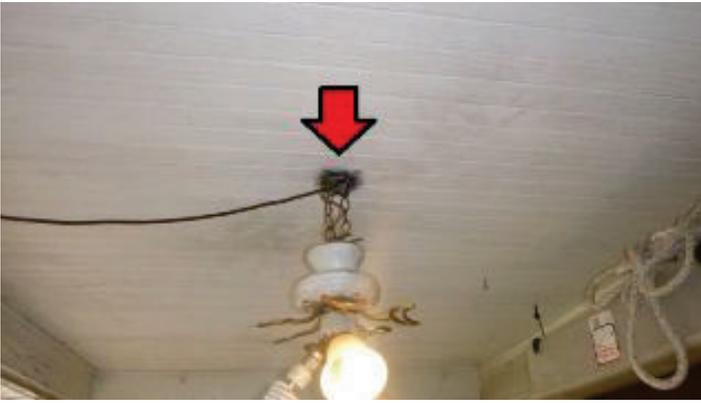
Light fixture is hanging by the wire in the screen porch.

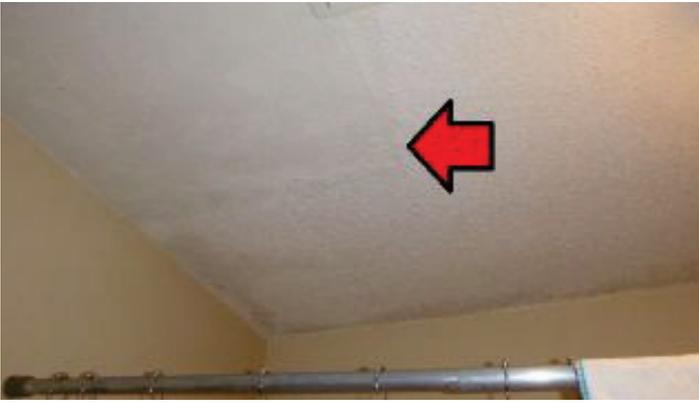
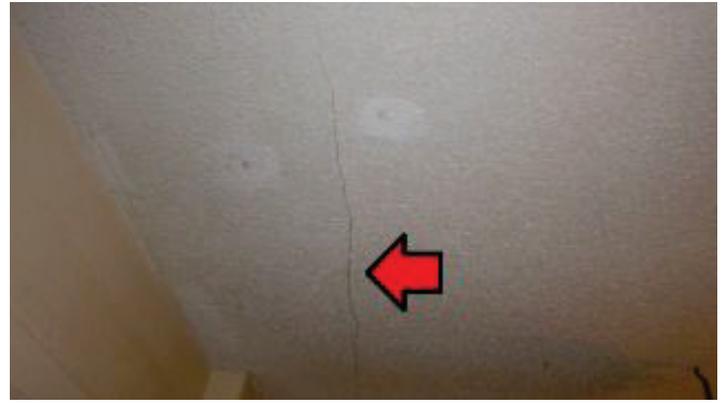
**Cosmetic Repair**

Water stains found on the ceiling or wall throughout the home. Moisture readings show leak to be an inactive leak (dry) at the time of inspection.

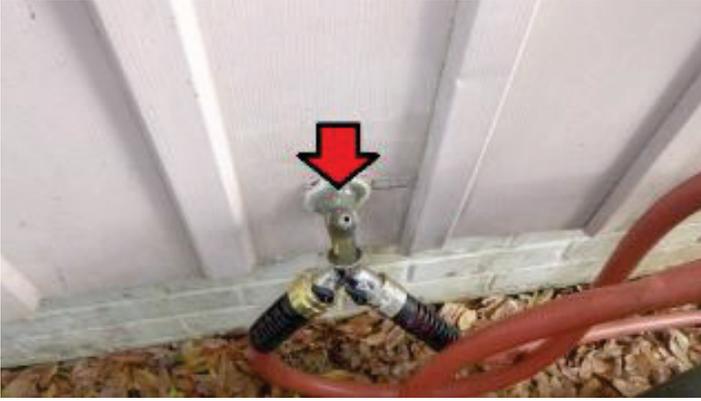
Hose bib faucet is missing a handle or has a broken handle on the home. Unable to test for proper function.

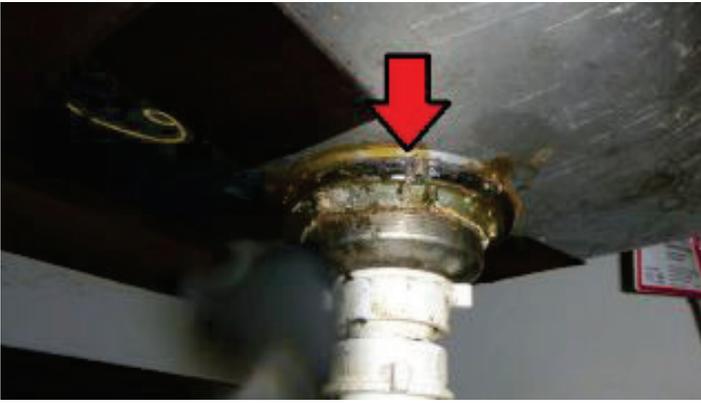
Active leak found on the drain line under the kitchen sink.

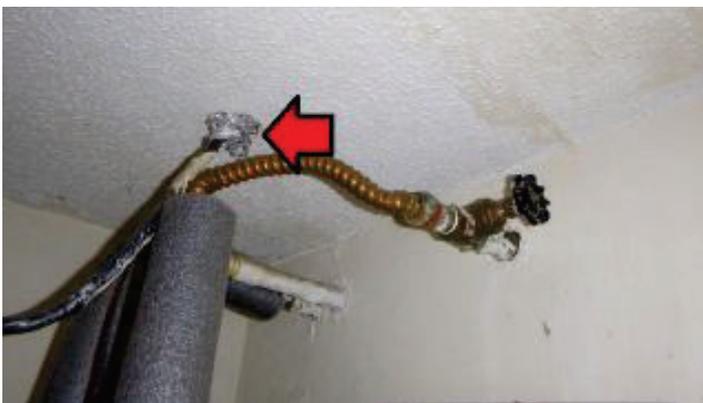
Safety Concern

Electrical disconnect box was not installed for the water heater. Todays construction requires a disconnect box if the breaker box is not with in view of the water heater.

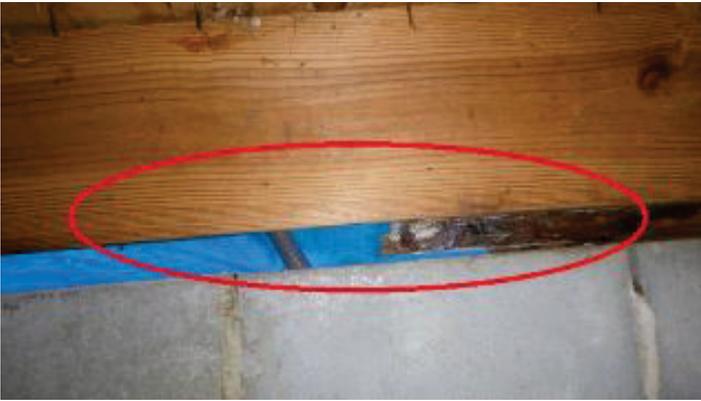
General Maintenance

Excessive opening in the sub floor under the bathrooms. This could allow pest or rodents access.
